# Aquatherm Technical Bulletin

201408A- AQTTB

## Protective Film

Date Issued: 7 August 2014

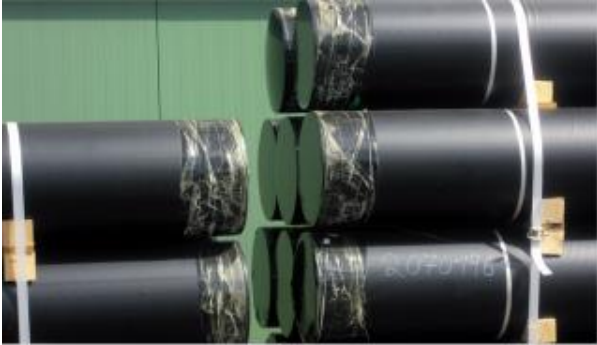
Figure 1: Sealed pipe ends.

Remember to remove the protective film before installing the Aquatherm pipe.

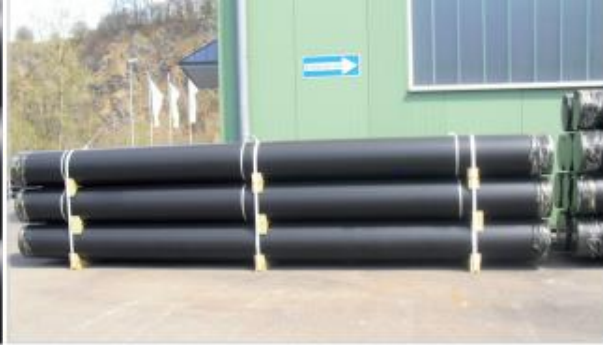
Figure 2 Outdoor Storage with film in good condition.

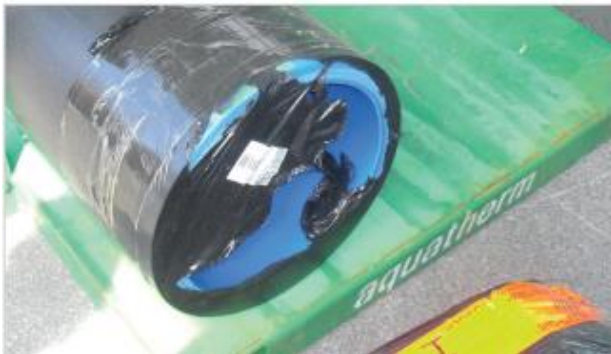
On the following page are pictures that show the protective film and possible damages to the film that can occur during transport. Damage to the film itself does not necessarily affect the quality of the pipe, assuming the pipe is not damaged at the same time and is not subjected to long-term UV exposure as a result of the damaged wrap.

Figure 3 Possible damages caused by container loading.

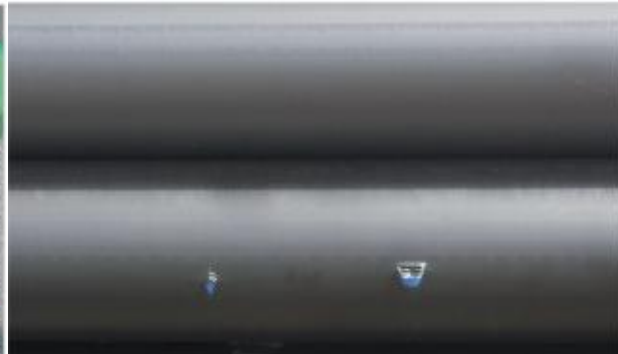
Figure 4 Possible damage caused by handling.

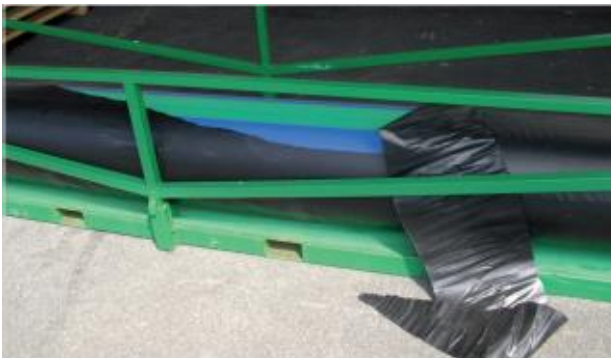
Figure 5 Possible tearing from container loading.

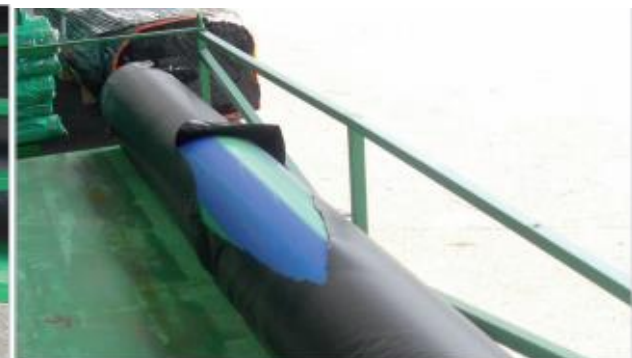
Figure 6 Possible tearing from container loading.
