PIPING SOLUTION WITHSTANDS HEAT IN FLOOD DISASTER

Monroe Carell Jr. Children's Hospital at Vanderbilt University, Utility Tunnel

aquatherm blue pipe®

Nashville, TN
June 2008

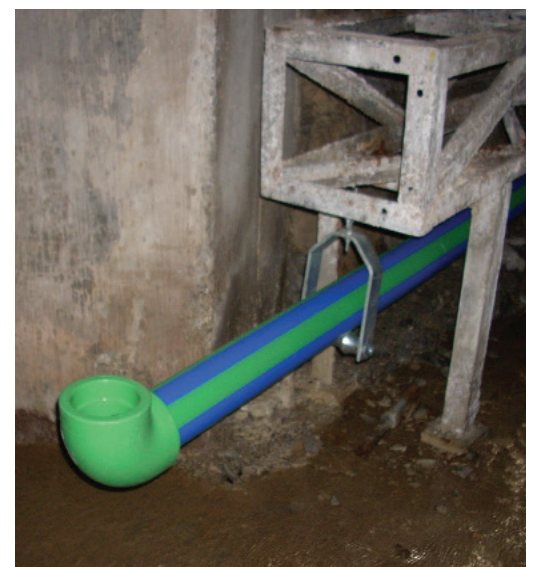
The tunnel was dug about a decade ago to depths ranging between 100-140 feet to transport electrical conduit, steam supply, steam condensate, 300 psi natural gas, chilled water and pneumatic control lines. Eight and a half feet in diameter, it runs between the university power plant and the Monroe Carell Jr. Children's Hospital at Vanderbilt.

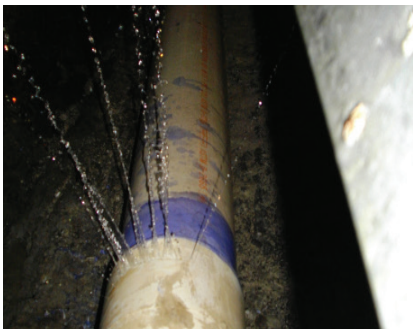
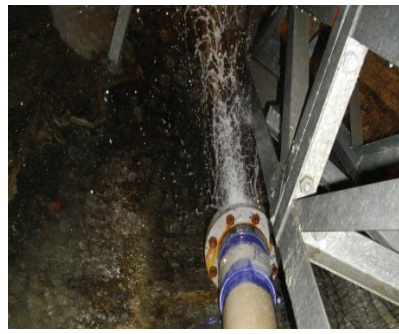
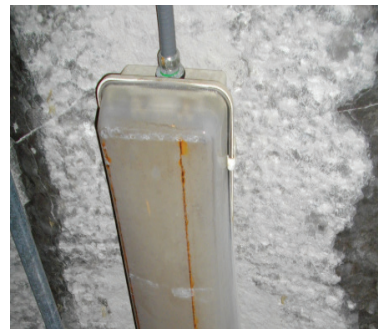
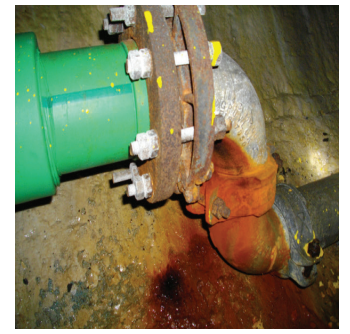
But all of this was only part of Cook's problem back in 2008. The combination of groundwater seeping in from natural springs, rainwater trickling in, and condensate building up in the space had taken their toll on the existing galvanized steel piping. Additionally, some joints were leaking.

In the deepest part, where the tunnels meet at the “V,” two Gorman-Rupp submersible pumps are tied into Aquatherm Climatherm polypropylene-random pipe in order to remove the ground water and bring it to the plant where it is softened and used in the plant's cooling towers. The system also features a three-inch Climatherm line to the main plant for flushing the lines to a sewer.

“The steam lines heated the tunnel and its contents to the point where the plastic light fixtures melted, but the Aquatherm stayed completely intact. We were amazed that it held up and it was a saving grace,” he added. Using a supplemental sump pump and the Aquatherm piping, the V.U. staff was able to get the old pumps out and install new ones and remove all of the water in about three days.
