AQUATHERM HELPS DRY UP INDUSTRIAL LAUNDRY FACILITY'S LEAK WOES

PROJECT	PRODUCTS USED	LOCATION / DATE
Tri-State Health Care Laundry, Supply and Process Water Retrofit	Aquatherm Greenpipe® Climatherm®	Covington, KY Summer 2008

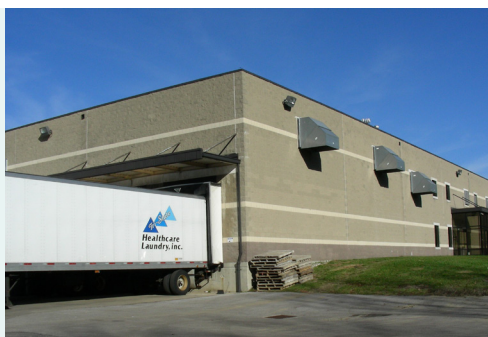
- PP-R's lighter weight made installation from a scissor lift easier
- 4-inch joint connections took only 3-4 minutes vs. 15 with steel
- Ownership liked the corrosion resistance and 10-year warranty

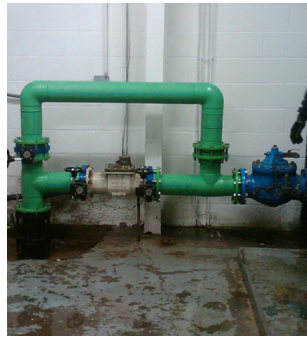
After seeing PP-R perform so well for three years, Tri-State installed it for its six-inch main line.

More than a year later, the repairs are holding up perfectly, and Tri-State now has a go-to piping option. In fact, Aquatherm was also used on the facility's six inch main line in summer 2011. ^a

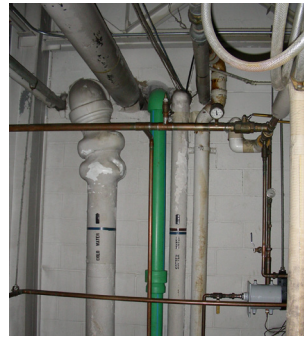
The soft water main runs from the three water softeners in the boiler room to the tunnel washers at the back of the facility. It is a run of approximately 400 feet.
